Eastern Washington Stormwater Effectiveness Studies

Technical Evaluation Report (TER)

Street Sweeping and Catch Basin Cleaning Comparison

Study Classification: Operational BMPs

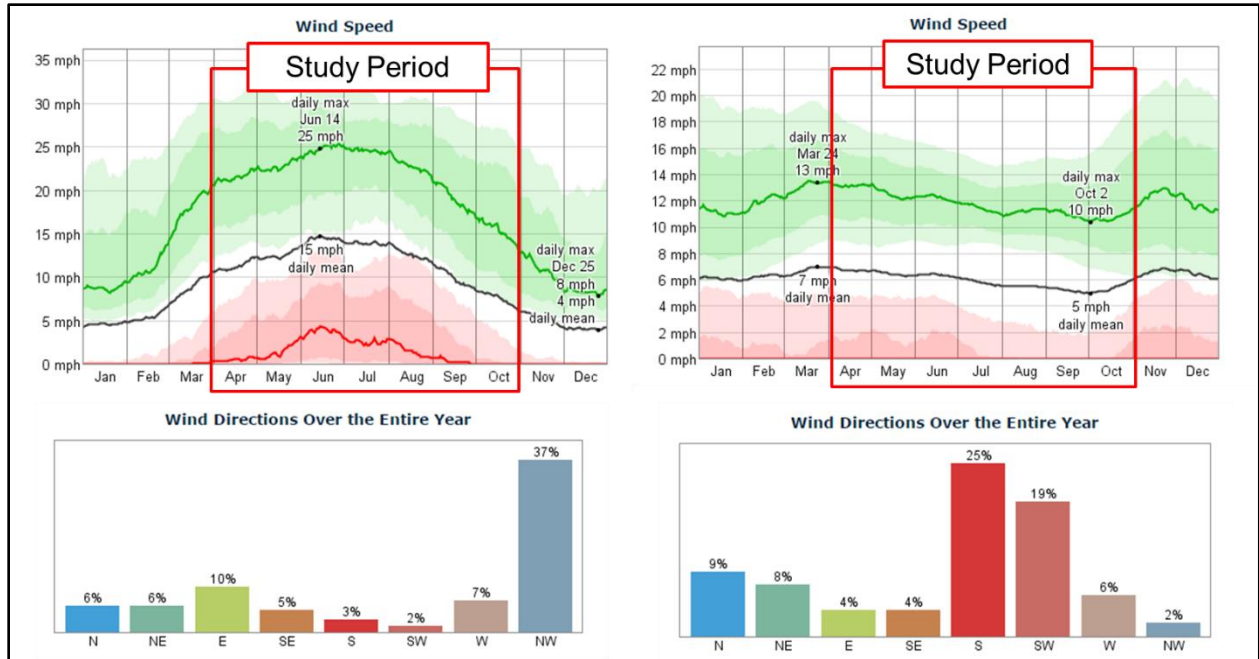
Figure 3.1 Average daily wind speeds in Ellensburg (left) and Olympia (right)
 (Source: <https://weatherspark.com/averages>)

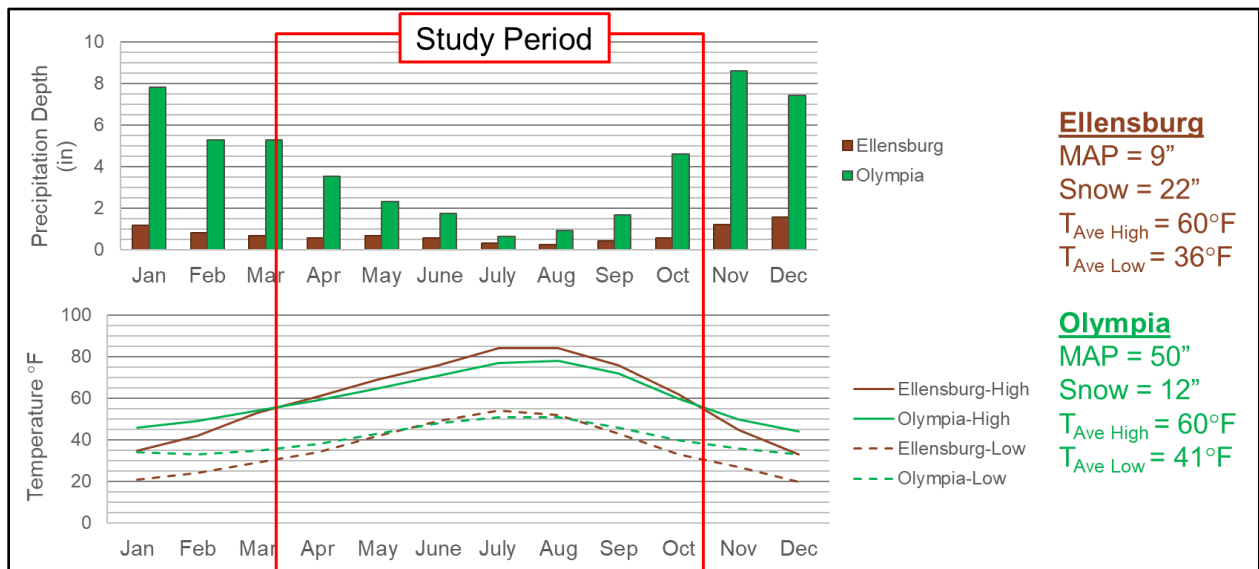
Figure 3.2 Average monthly precipitation depth and temperature in Ellensburg (brown) and Olympia (green)
 (Source: <http://www.usclimatedata.com>)

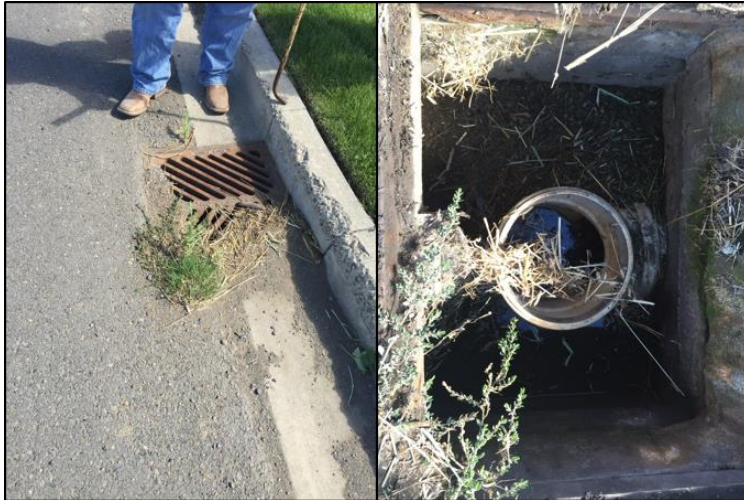
Figure 3.3 Proposed study area: typical roadway and catch basin sediment accumulation

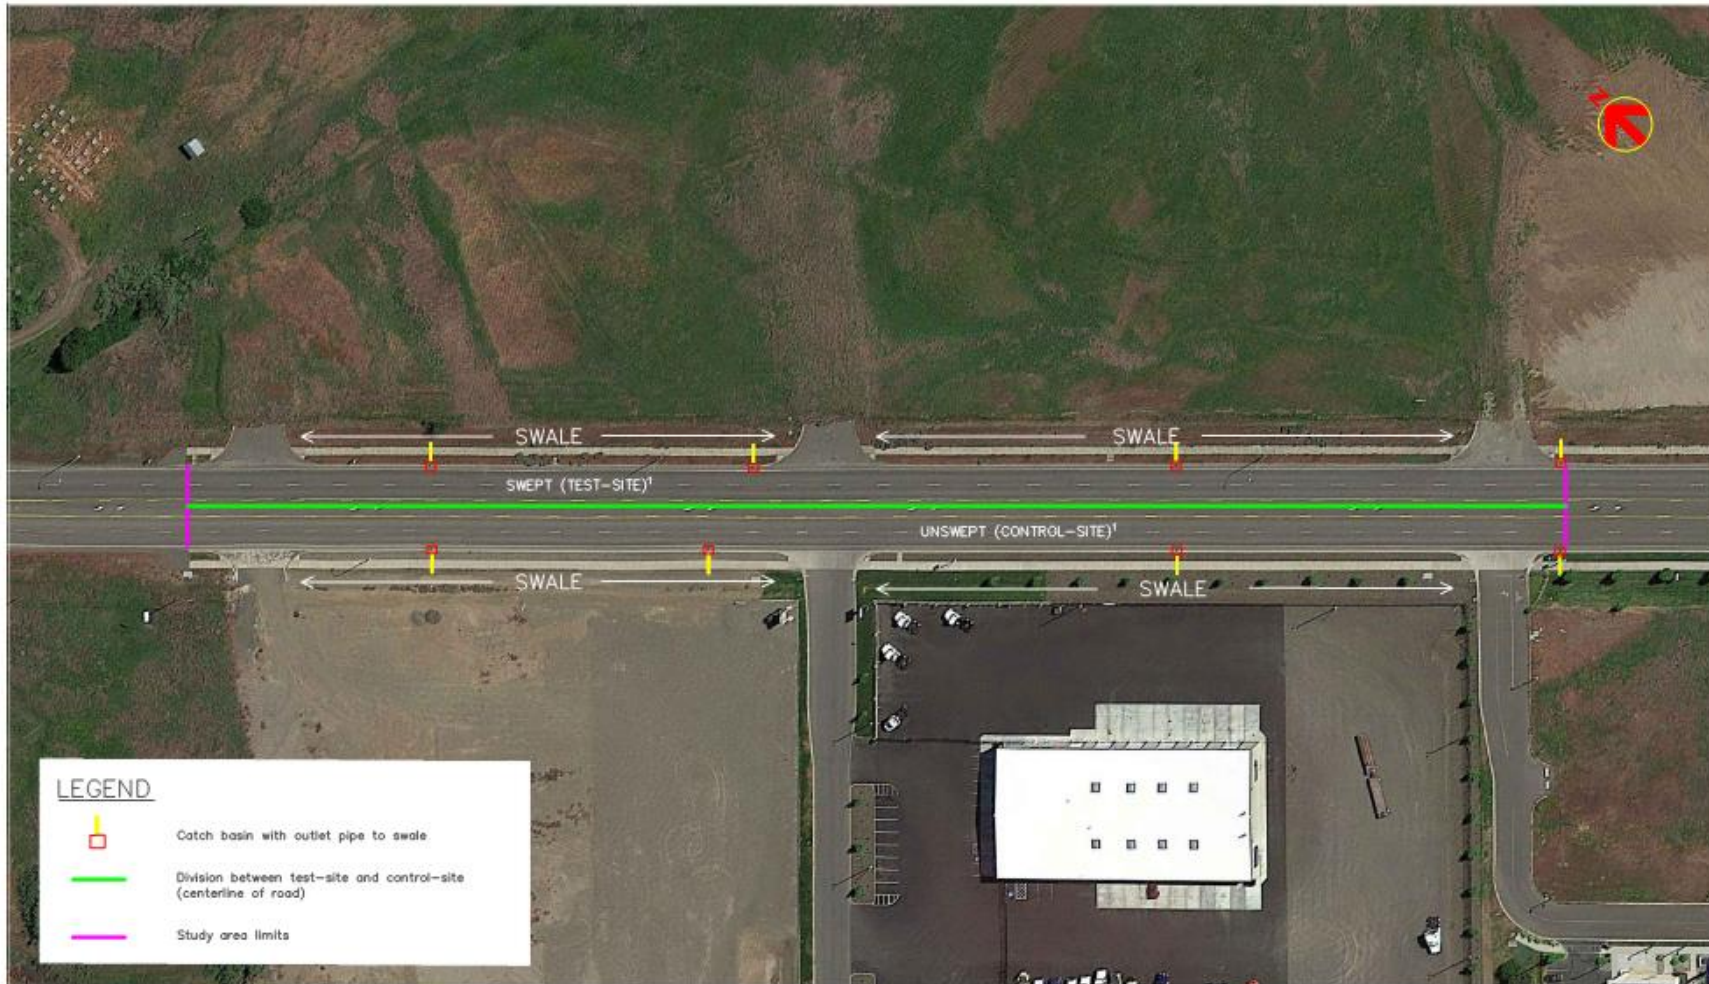
Figure 3.6 Aerial view of the proposed study area showing the locations of the test site and control site

¹ The test-site and control-site will switch to the other sides of the road for year two.

The proposed study area was a 1065-foot section of road on State Route 97 located in Ellensburg, Washington between Desmond Road and West University Way (Figure 3.6). This principal arterial is a major hay hauling route and the land use in the study area is primarily commercial and light industrial. The road has four 12-foot lanes, a 12-foot turning lane, and two 4-foot shoulders (Figure 3.7). The speed limit on the road is 40 mph with an approximate average daily traffic (ADT) of 4000. The study location was selected because the proposed test site and control site provide equivalent areas for comparison including:

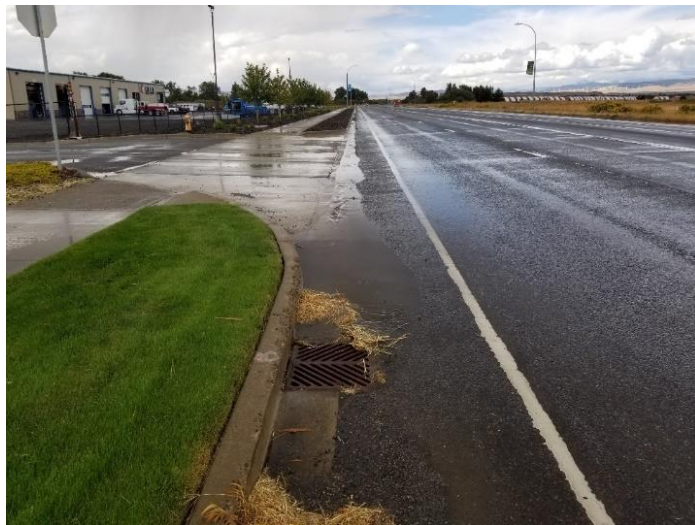
Figure 3.9 Approaches contribute runoff to catch basins

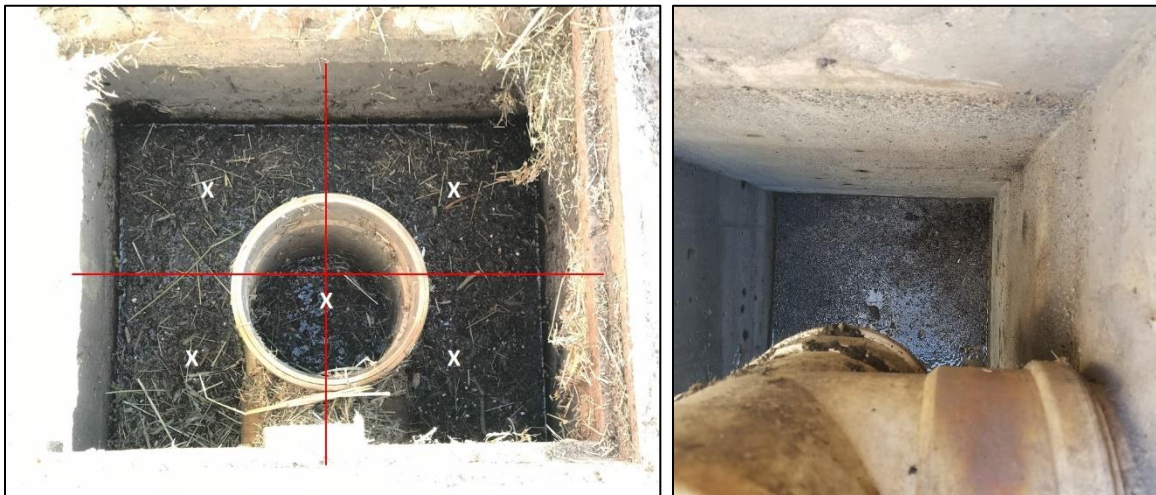
Figure 5.2 Catch basin sediment depth: measure in five locations full (left) and empty (right)

The depth of sediment in each catch was measured using a fiberglass, telescoping survey rod with hundredths of a foot gradations. This included measuring from the rim of the catch basin to the top of the sediment in five different locations (Figure 5.2) before cleaning catch basins and subtracting these measurements from the depth of the catch basin empty. The average sediment depth in each catch basin was determined by averaging the five measurements. The SOP for measuring the sediment depth is located in Section 8.1.1 of the QAPP.

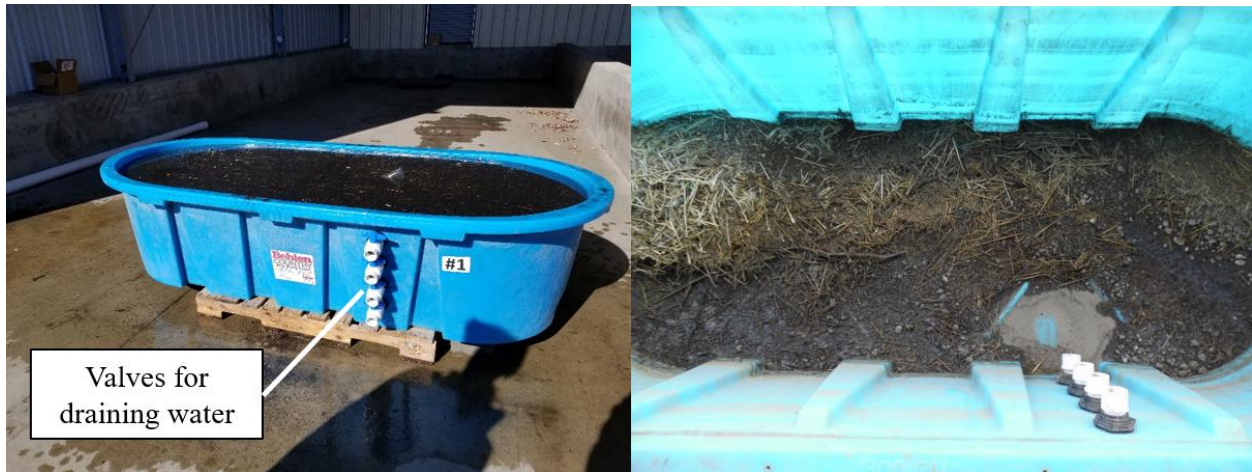
Figure 5.4 Dewatering Basin Prior to Settling (Left) and Following Dewatering (Right)

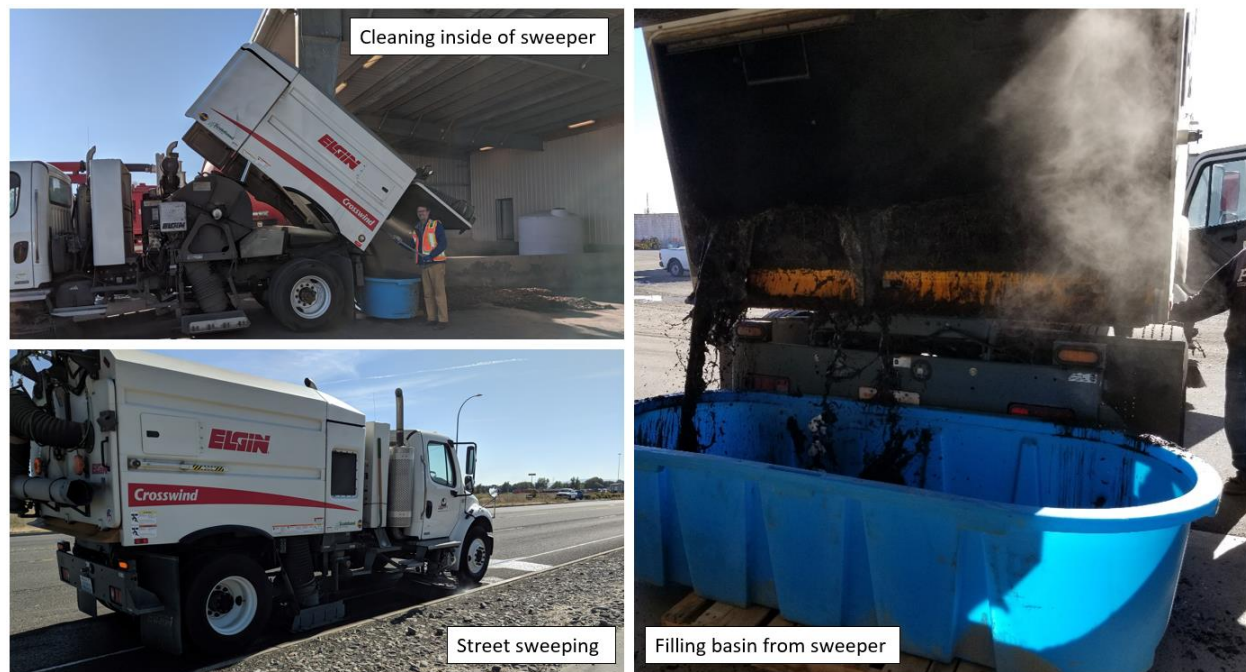
Figure 5.5 Roadway Sediment Accumulation Data Collection

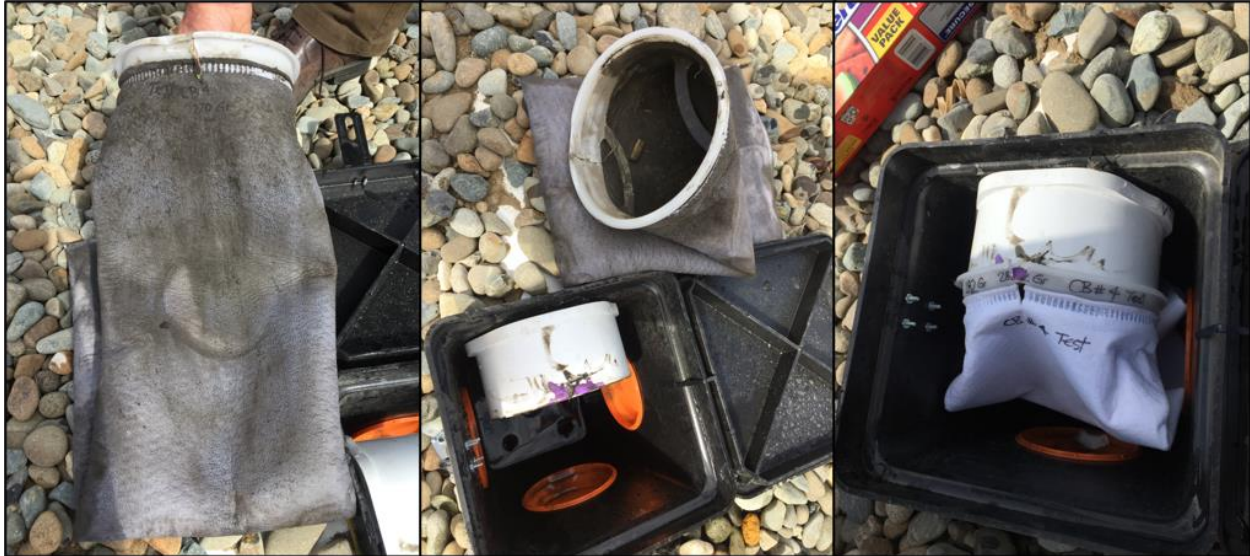
Figure 5.7 Catch Basin Socks: after 2 months use (left), uninstalled (middle), installed and new (right)

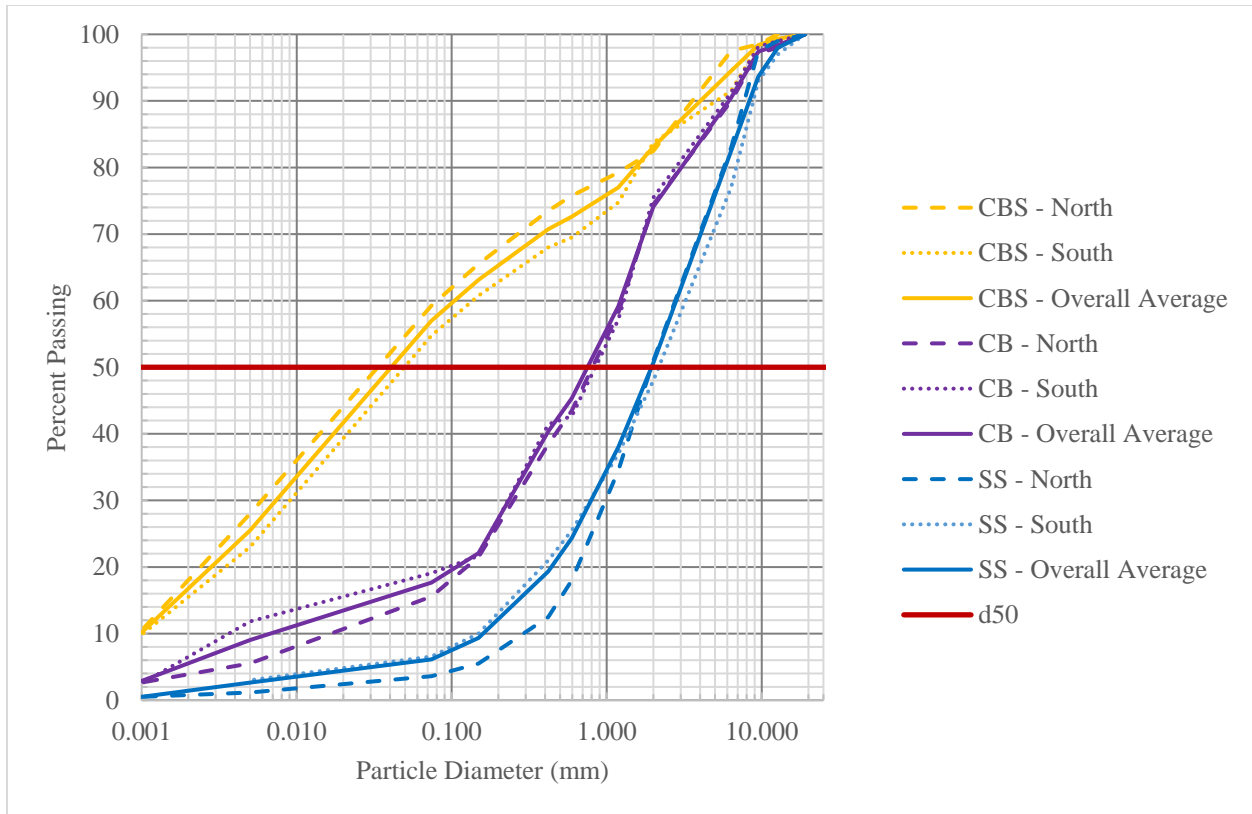
Figure 7.1 Semi Log Graph of Average Sediment PSD

As shown in Figure 7.1 the largest sediment was collected from the street (d₅₀=2.0mm) followed by the sediment collected in the catch basins (d₅₀=0.8mm) with the smallest sediment washed from the catch basin into the socks (d₅₀=0.05mm). Based on the d₅₀ measurements, the sediment is classified as very fine gravel to very coarse sand (Street Sediment), coarse sand (catch basins), and silt (catch basins socks). These results are consistent with other studies which suggest that street sweepers are more efficient for picking up the larger size sediment while smaller sediment (d₅₀<0.10mm) can washout of catch basins (Elgin, 2009; Tang, 2016; Rockford et. al., 2009).

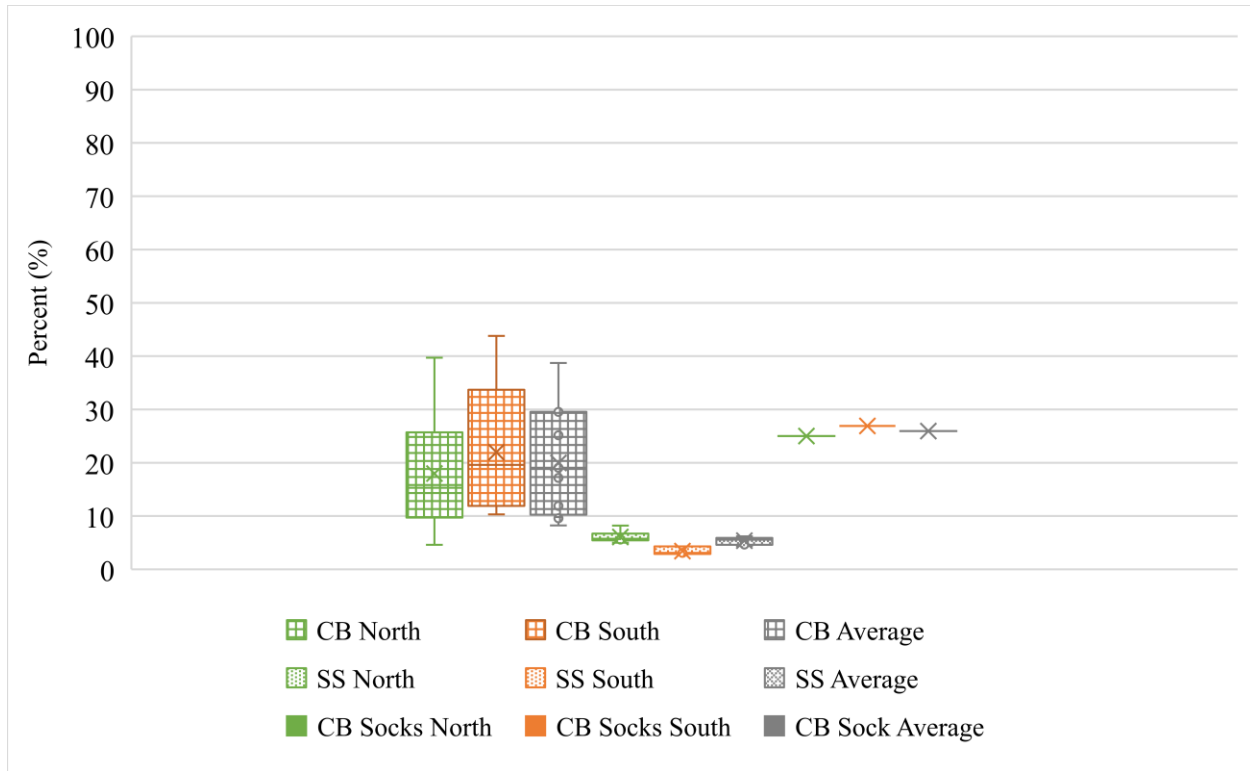
Figure 7.2 Distribution of Organic Content in Catch Basin, Street Sediment, and Catch Basin Socks

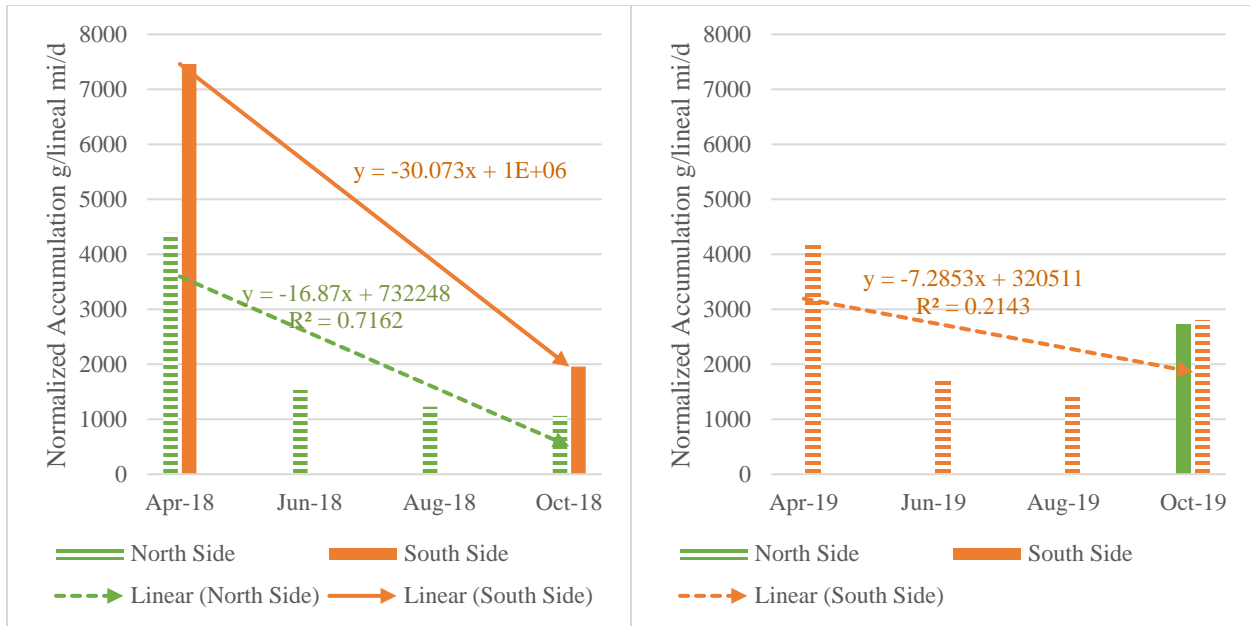
Figure 7.4 Comparison of Normalized Street Sediment Accumulation Rate from 2018 (left) and 2019 (right)
 Note: Hatched bars indicate test side and solid bars indicate control side.

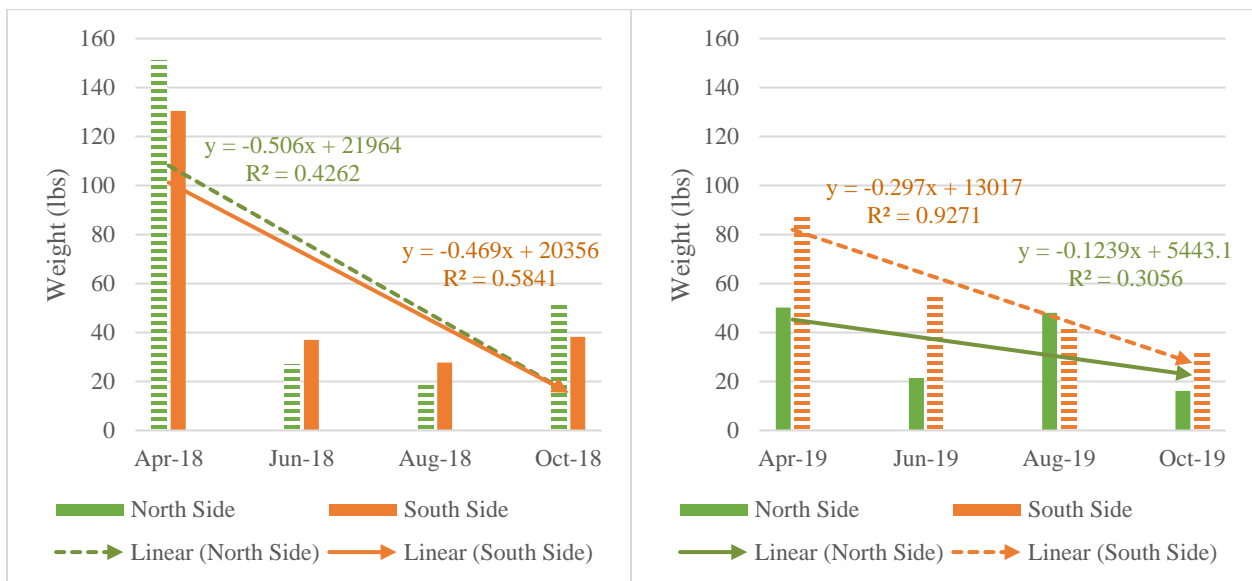
Figure 7.5 Comparison of Catch Basin Sediment Dry Weight Collecting during 2018 (left) and 2019 (right)
 Note: Hatched bars indicate test side and solid bars indicate control side.

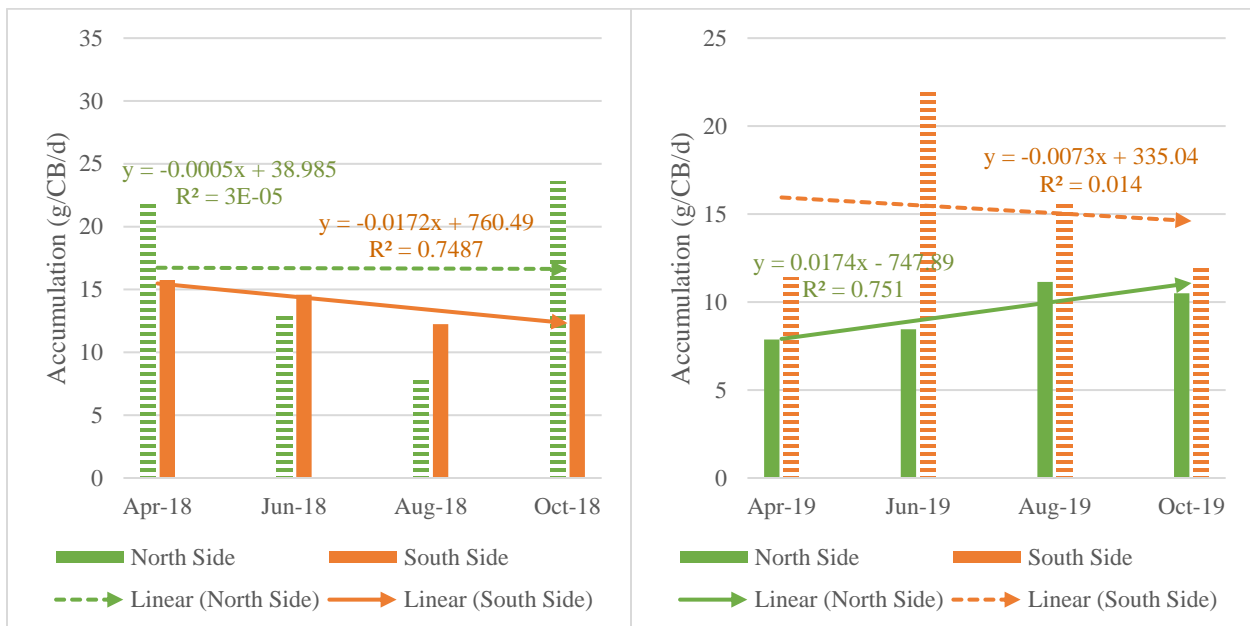
Figure 7.8 Comparison of Catch Basin Normalized Accumulation Rate During 2018 (left) and 2019 (right)
 Note: Hatched bars indicate test side and solid bars indicate control side.

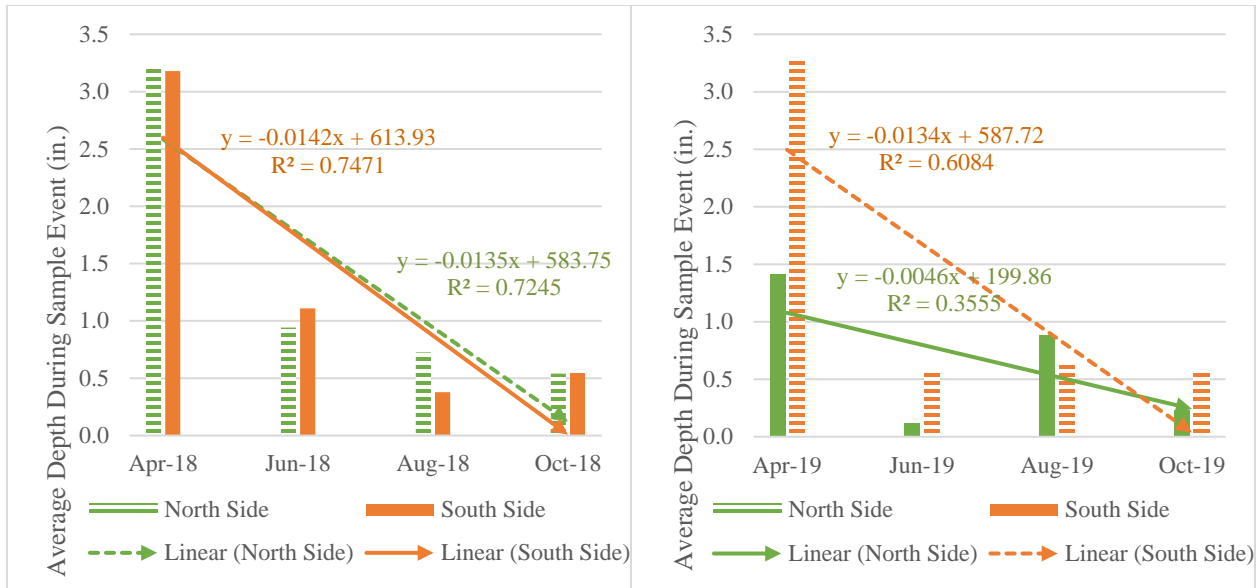
Figure 7.9 Comparison of Catch Basin Sediment Depth During 2018 (left) and 2019 (right)

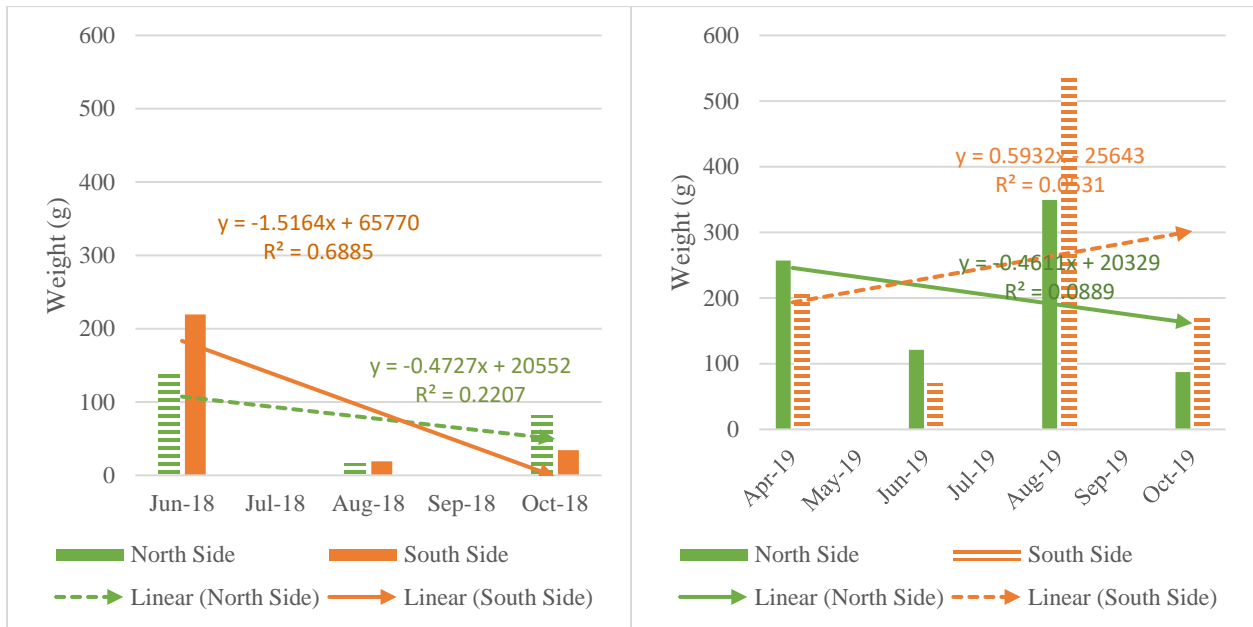
Figure 7.11 Comparison of Catch Basin Sock Sediment Dry Weight Collected in 2018 (left) and 2019 (right)
 Note: Hatched bars indicate test side and solid bars indicate control side.

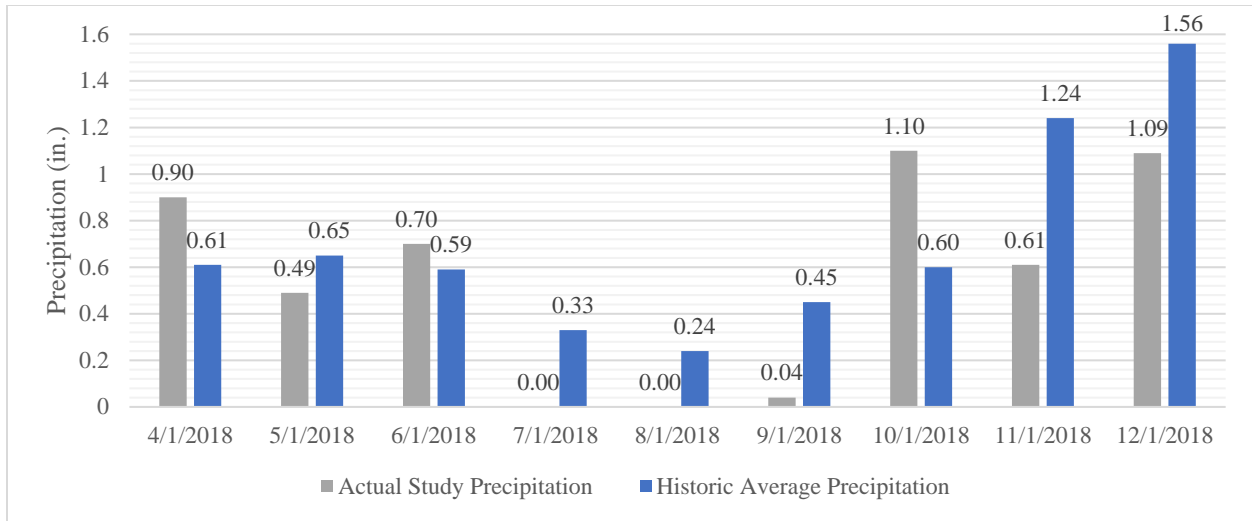
Figure 7.13 2018 Precipitation During Study vs. Historic Average Precipitation

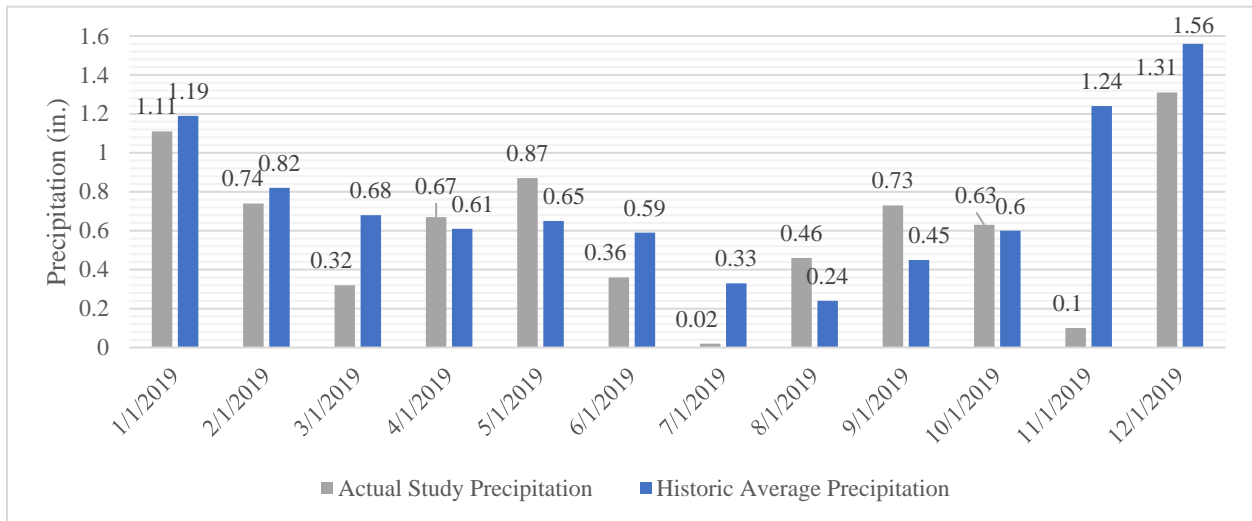
Figure 7.14 2019 Precipitation During Study vs. Historic Average Precipitation

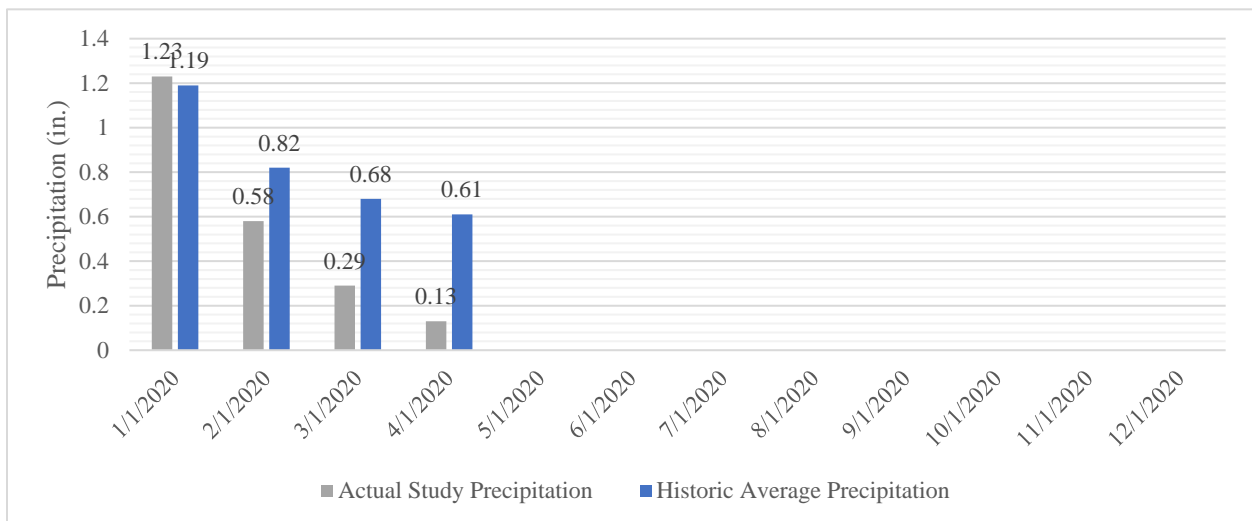
Figure 7.15 2020 Precipitation During Study vs. Historic Average Precipitation

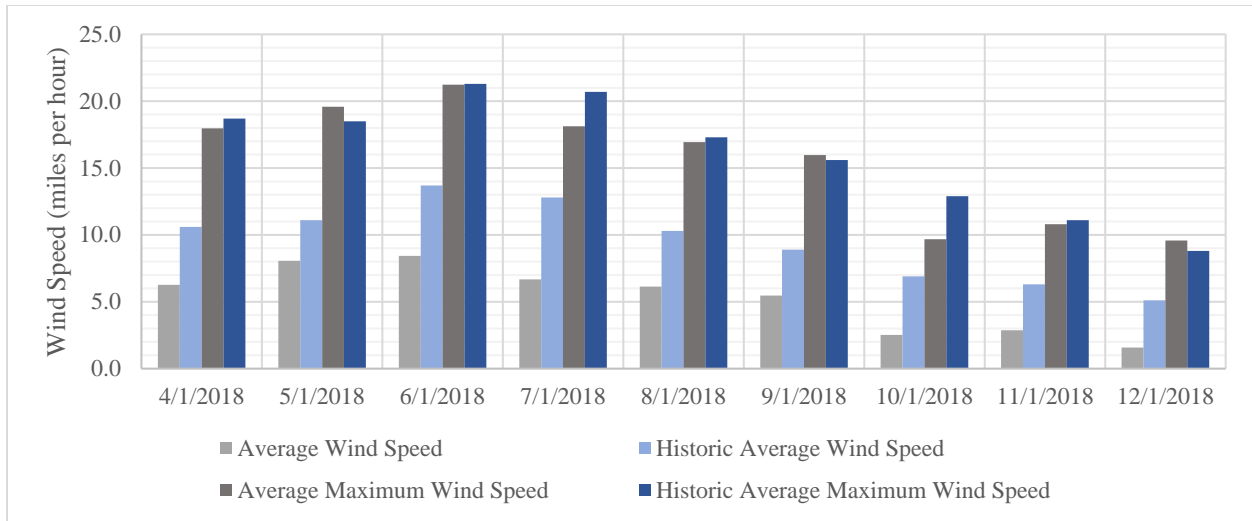
Figure 7.16 2018 Average Monthly Wind vs. Historic Averages

The historical wind speed (average and maximum monthly) in Ellensburg is shown Table 7.15 and Figures 7.13-7.15 along with the measured values during this study. The average wind speed measured (April 2018 to April 2020) was slightly lower compared to historical (4.8 mph compared to 9.0 mph) however the average maximum wind speed was about the same (15.1 compared to 15.5 mph). Wind is known to convey sediment into catch basins (solids less than 5 mm) and even influence sediment washout (smaller solids) from catch basins (Fan, 2004). The lower average wind speed may have reduced the transport of sediment to catch basins.

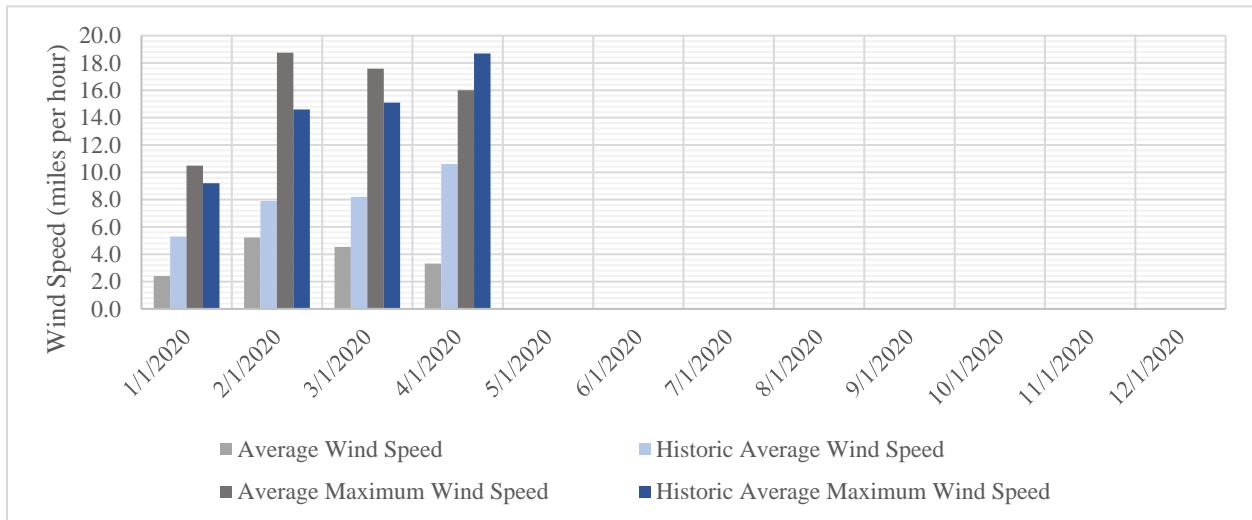
Figure 7.18 2020 Average Monthly Wind vs. Historic Averages

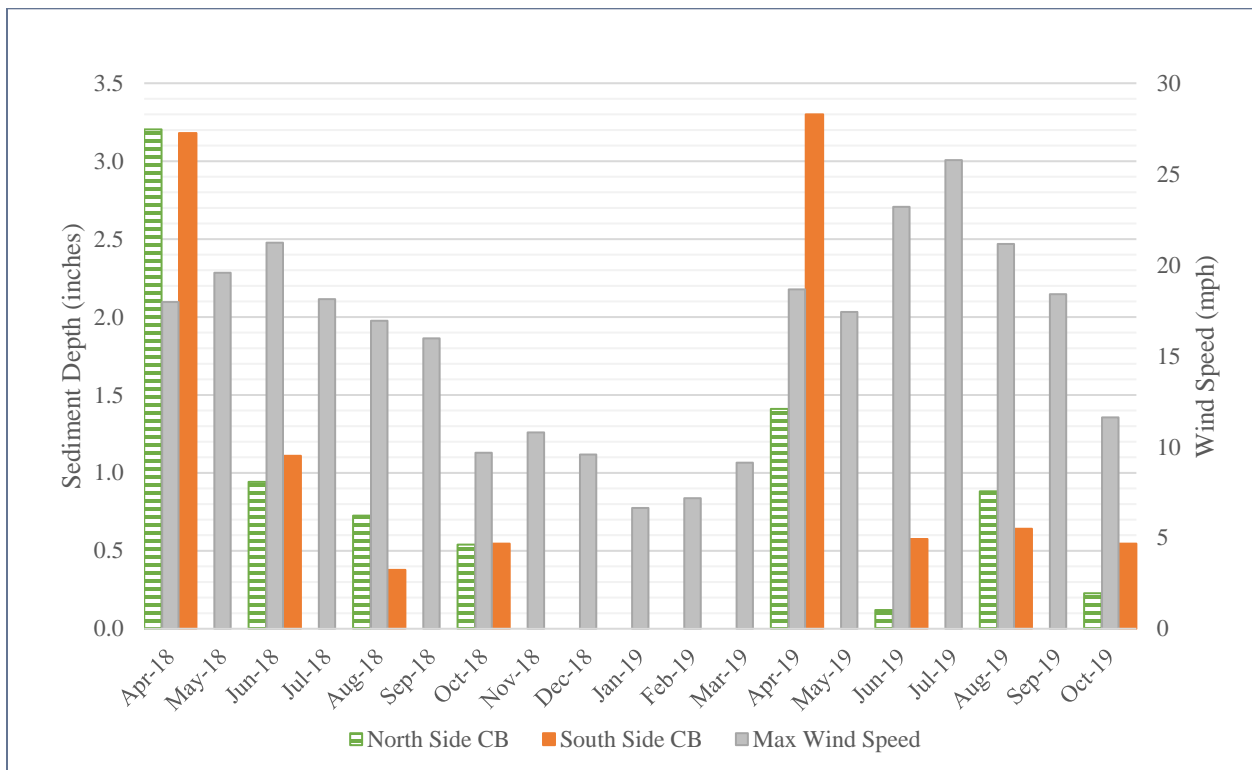
Figure 7.20 Sediment Depth Measured in Catch Basins and Average Monthly Maximum Wind Speed

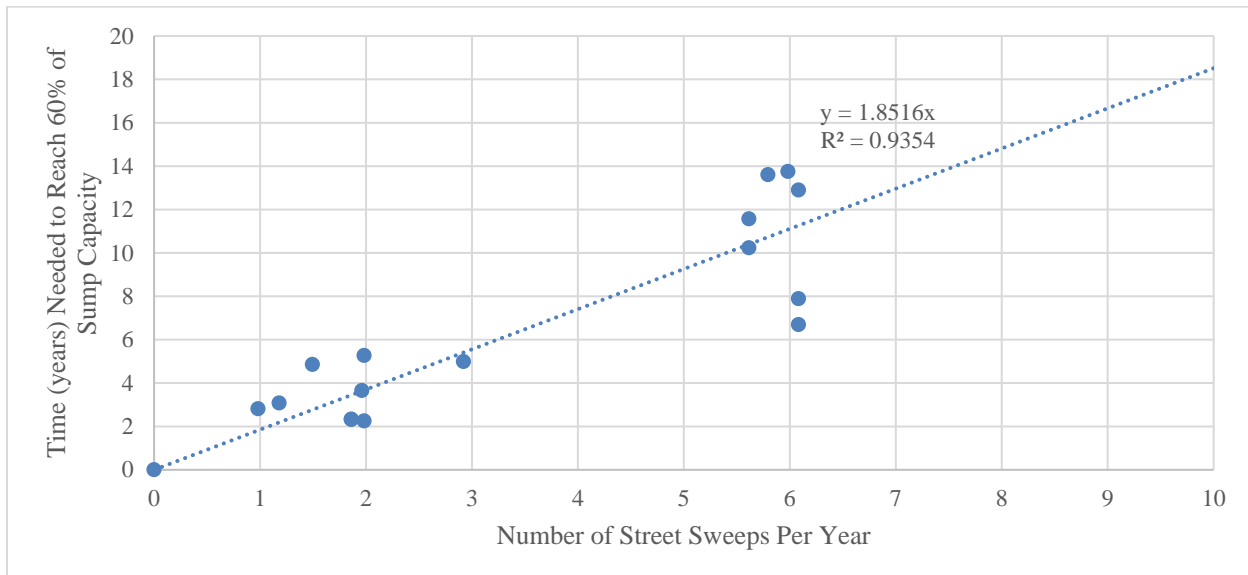
Figure 8.1 Recommend Catch Basin Cleaning Frequency based on Frequency of Street Sweeping

Objective 5 was achieved by using data collected from the study to develop a relationship between street sweeping frequency and catch basin cleaning. Results from the analysis are shown in Figure 8.1 and the analysis methods are described in later in this section. The x-axis is the frequency of street sweeping each year that occurs at regular intervals during the dry season. The y-axis is the recommended schedule for cleaning catch basins which is based on the estimated time it would take for sediment to fill 60% of the catch basin sump. A linear least squares regression analysis was used to evaluate the relationship between street sweeping frequency and the time it would take for the catch basin sump to fill (60% full) and the results indicate a strong linear correlation ($R^2=0.9354$). An example of how Figure 8.1 could be used is if the City decides to sweep four times per year, it is estimated that the catch basins would need to be cleaned every ~7.5 years. These recommendations are specific to the site where the study was conducted. Section 8.2 provides a discussion regarding the transferability of this information to other locations.

- For each sample collection event, the average weight of sediment measured in the catch basin was divided by the estimated weight at 60% full using the trendline equation (139 lbs) to estimate how many years it would take to fill the catch basin to 60% the sump depth. The number of years to fill was plotted vs the number of sweeps per year that occurred when that sample was collected (Figure 8.1).

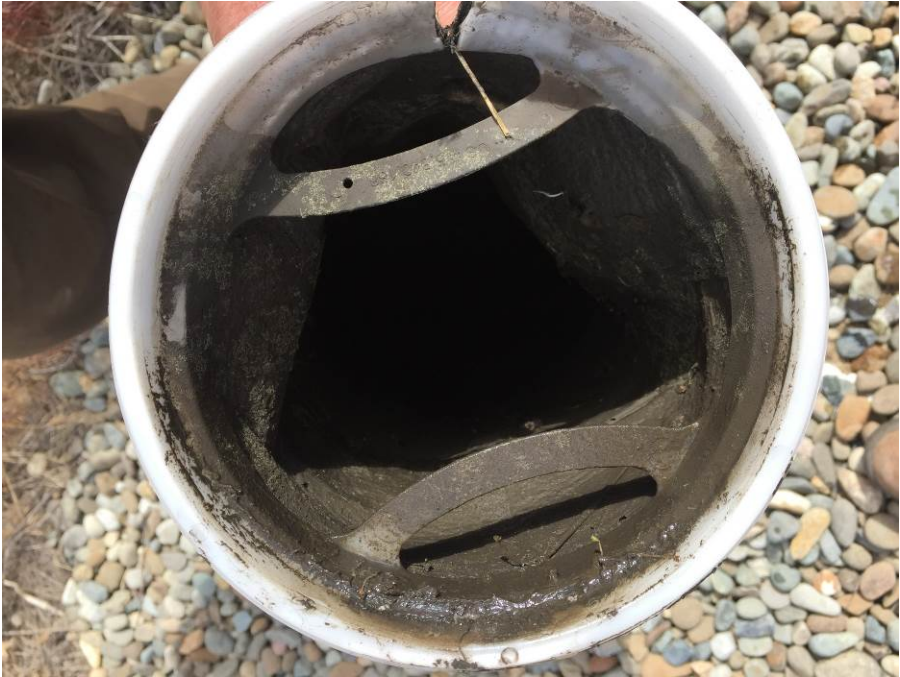
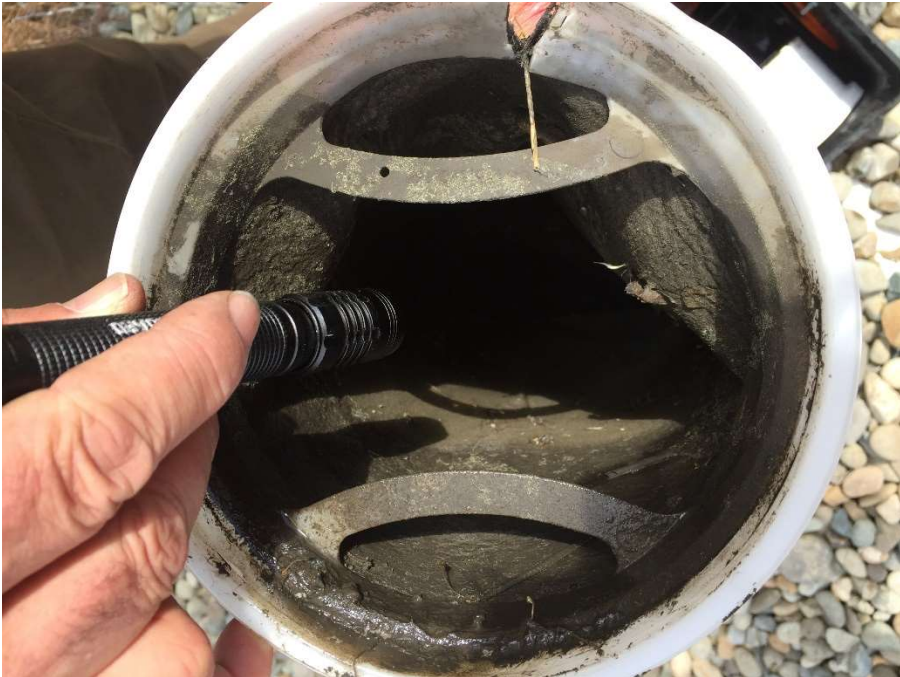
Sump sock for CB 4 shown above. Sump sock was removed and placed in a bag for dry weight and PSD sampling. Sediment accumulation reflects washout from the catch basin upstream between the April sampling event and June 19th.

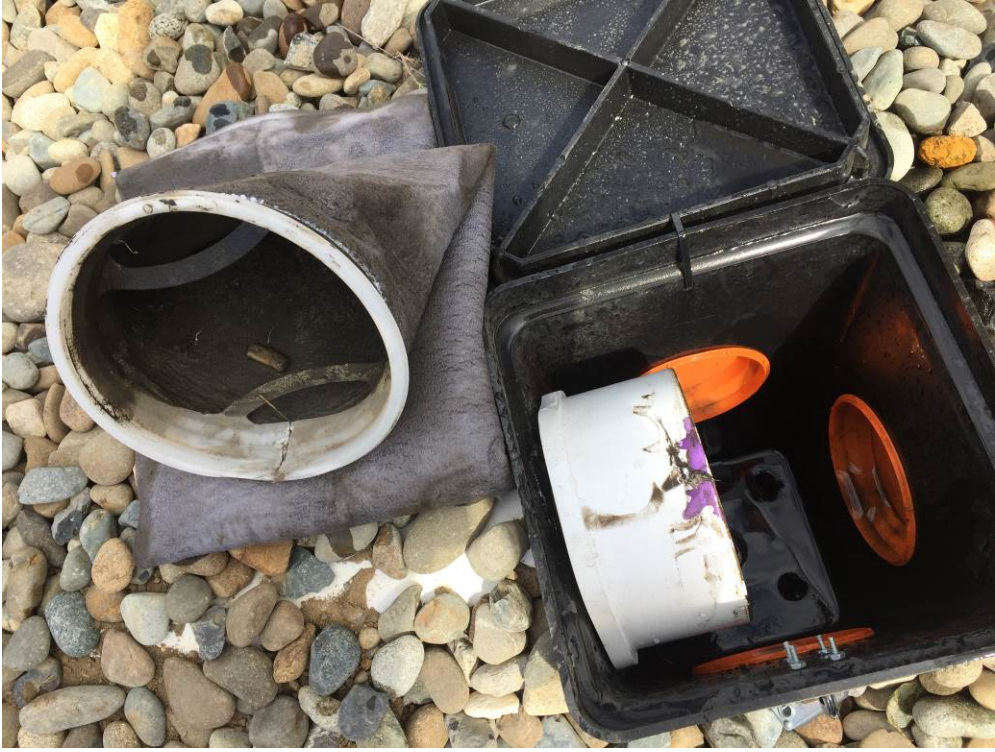
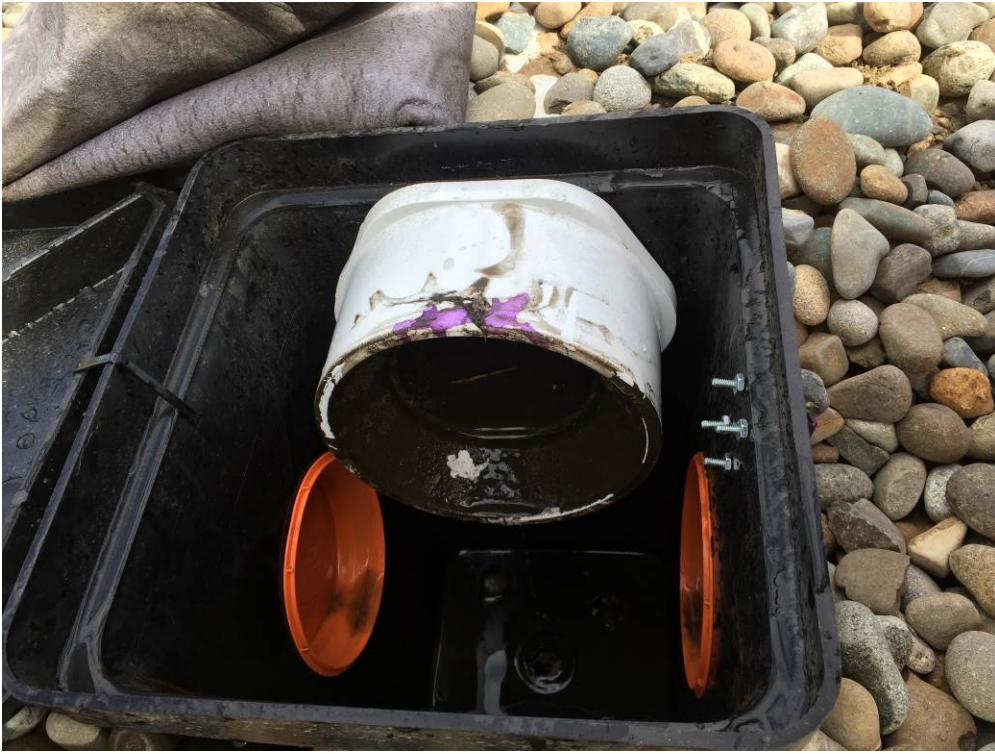
The same sump sock is shown next to the sump basin from which it was removed. The inside of the outlet pipe is coated in the same sediment as was in the sock. Care was taken not to lose any of the sediment in the pipe when removing the sock.

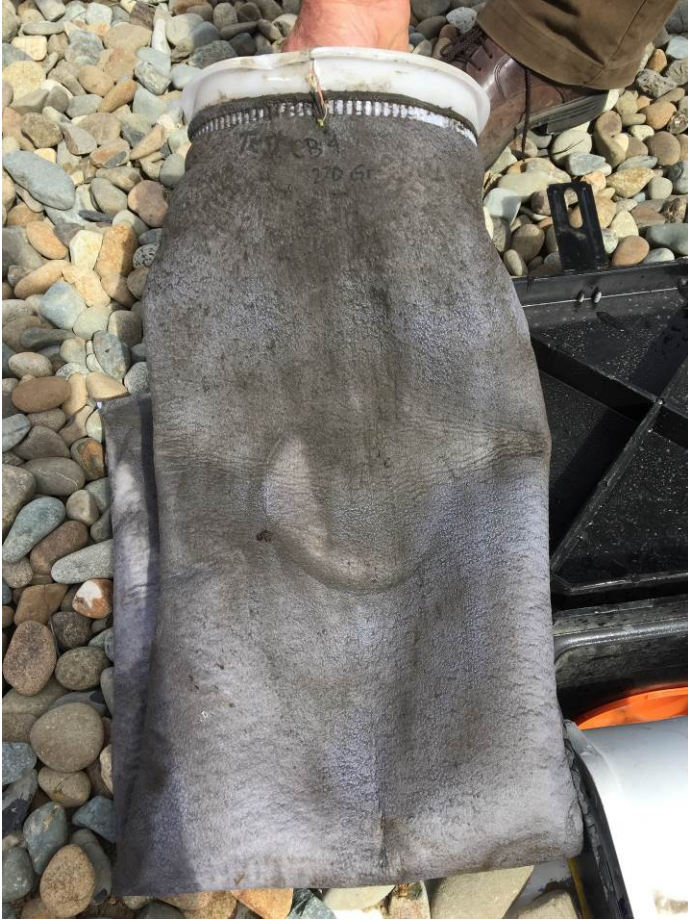
The photo above shows the removed sock with “Test CB4 270 gr” written on the sock. 270 grams is the clean/tare weight of the sock prior to when it was installed.
