Eastern Washington Stormwater Effectiveness Studies

Technical Evaluation Report (TER)

Street Sweeping and Catch Basin Cleaning Comparison

Study Classification: Operational BMPs

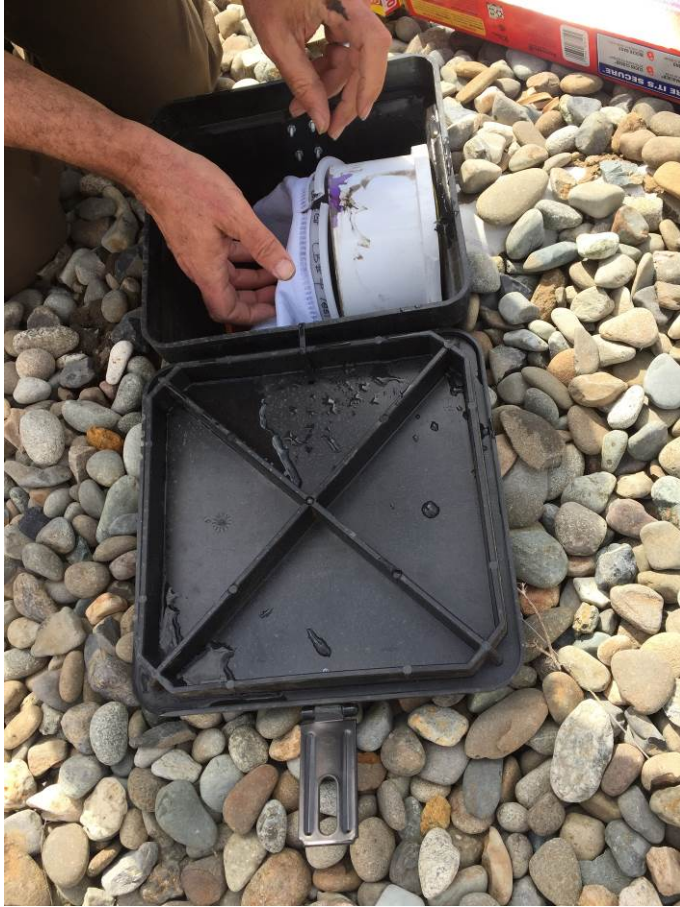
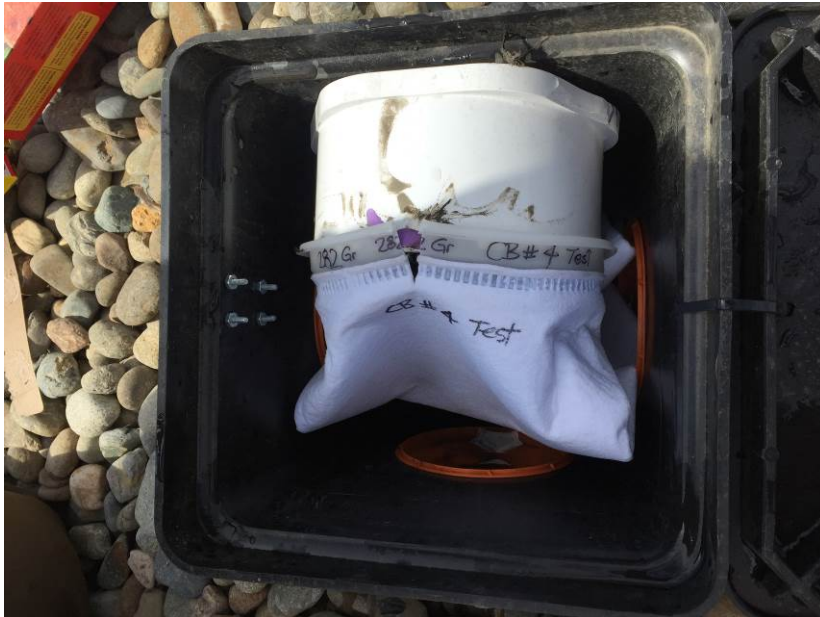
The above two pictures display the new clean sock being installed. The sock is folded and placed in the sump box, and gorilla tape/duct tape is placed around the plastic ring and across the cut in the sock (done intentionally to get the sock onto the pipe). The sock fits tightly onto the pipe.

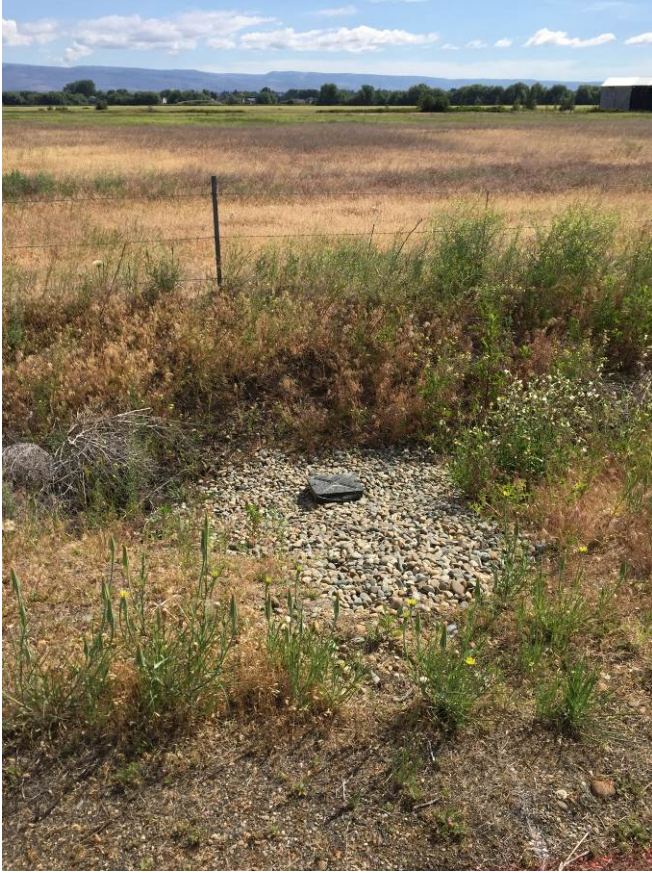
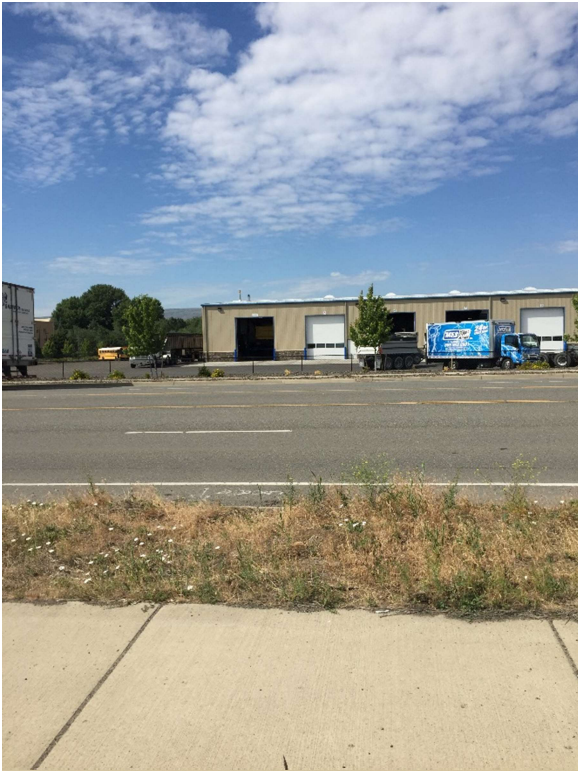
Photo of a closed sump box at the site and the upstream/area across the street

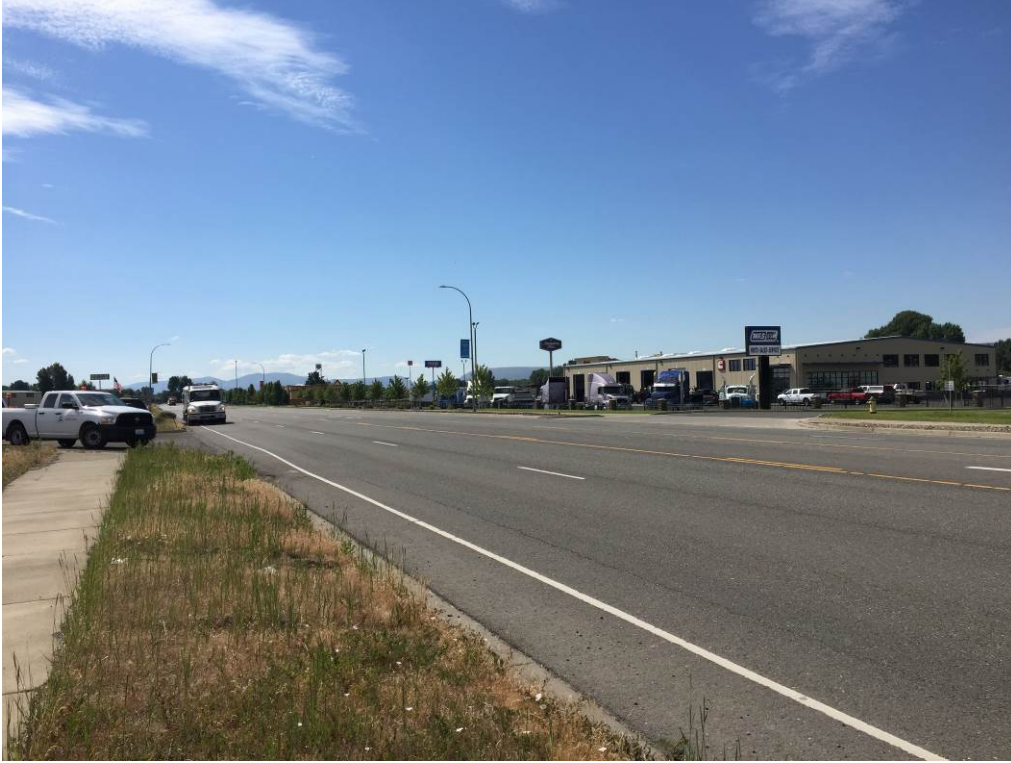
Picture of sweeper on the test side of the road (north)

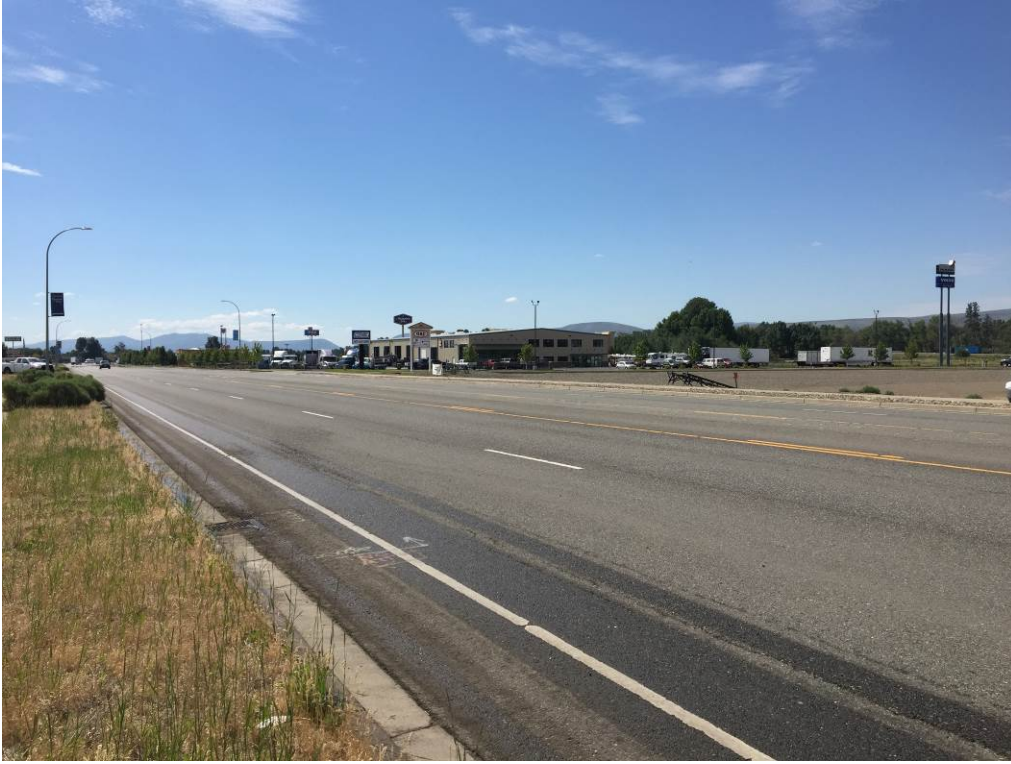
Picture of the road after swept

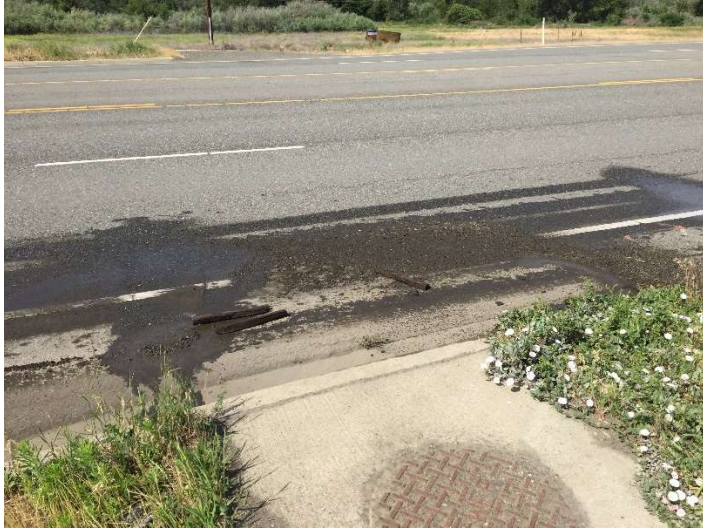
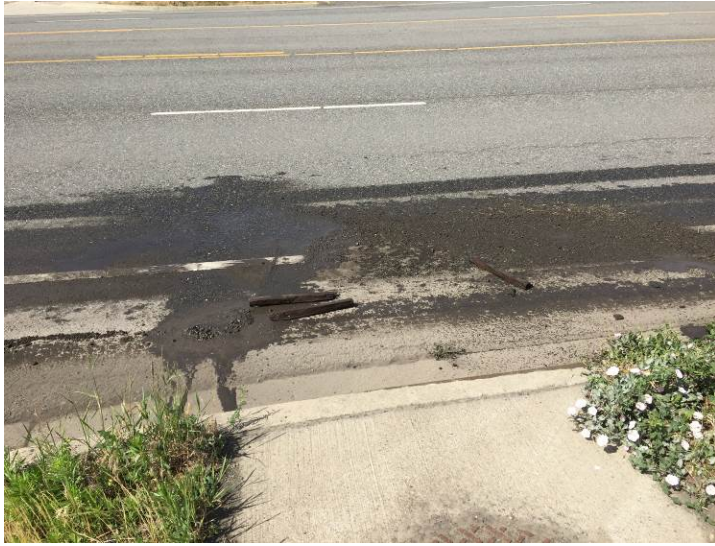
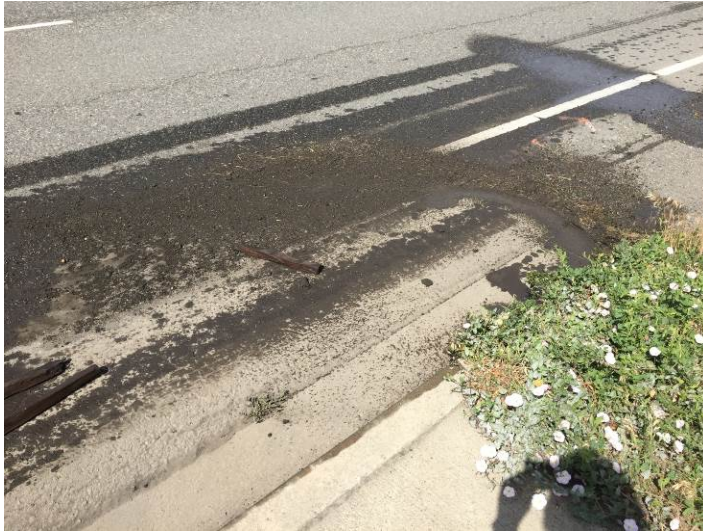
Material left behind after sweeper completed sweeping at site (just beyond crown/end of contributing basin) and lifted vacuum head below truck to drive away

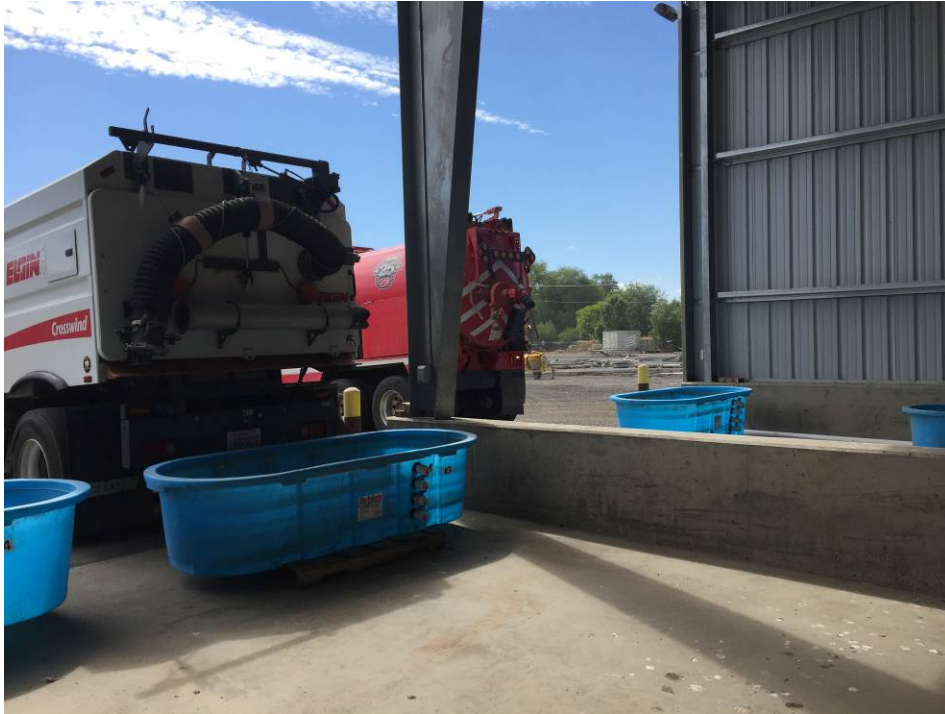
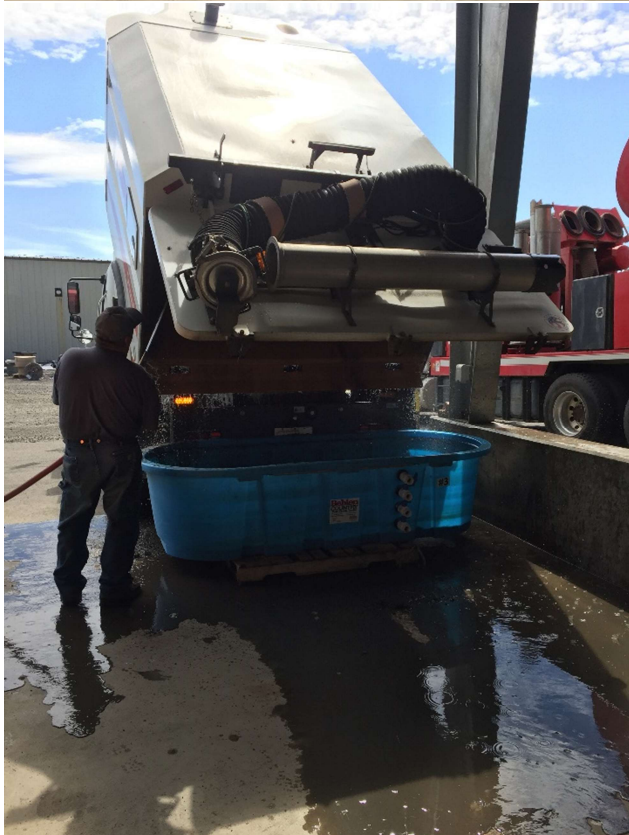
First photo shows the decant facility and basins with sweeper truck on the left and vactor truck on the right. Second photo shows the sweeper operator spraying out the inside of the debris tank to remove any remaining sediment inside the tank.

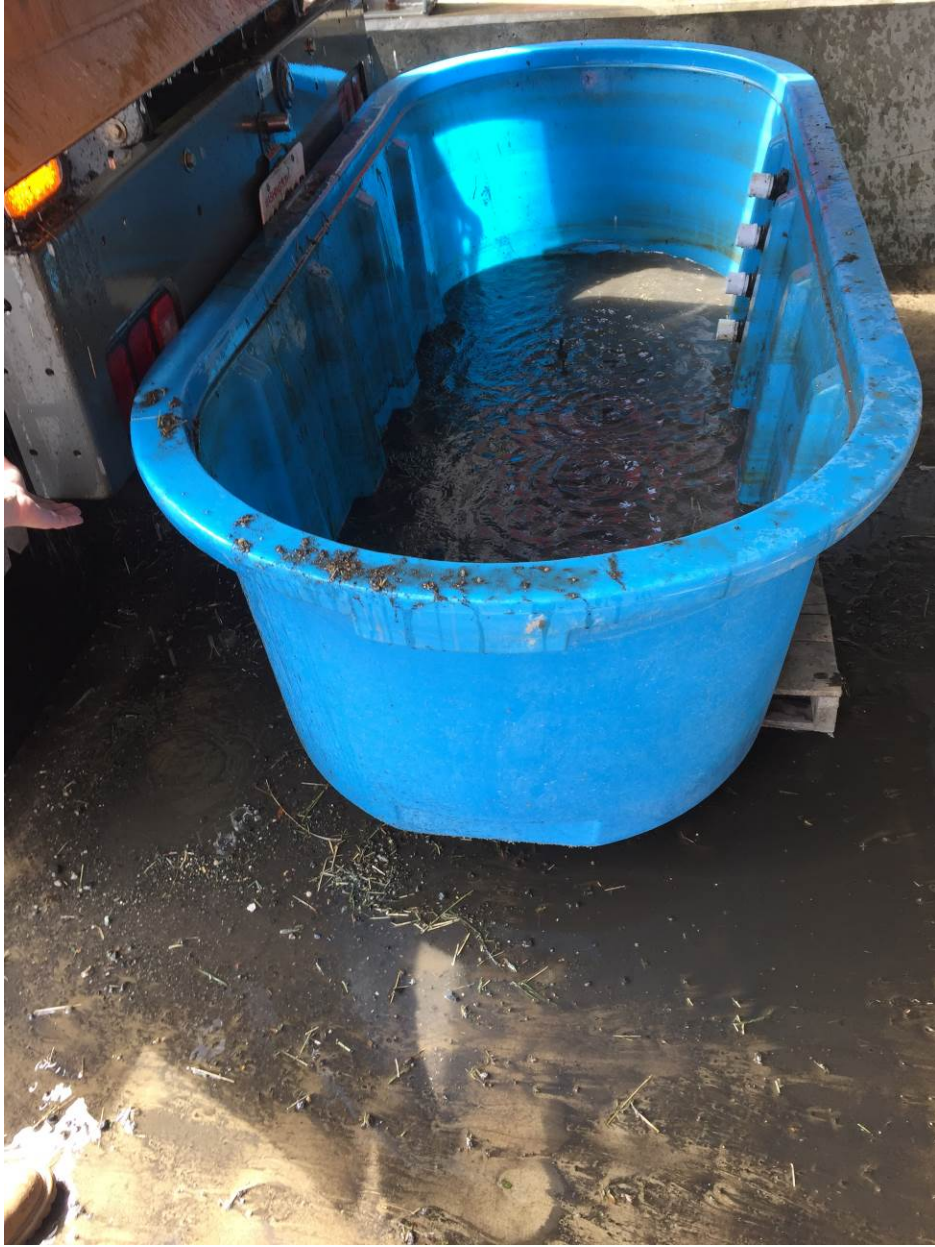
Photo shows street sweeping solids plus water used to wash out debris tank. Sediment on the decant facility floor (from emptying the sweeper debris tank) is typically allowed to dry and is scooped/shoveled into the basin with the rest of the sediment to minimize losses. Was told this amount is about 1/3 of what was collected from sweeping in April.

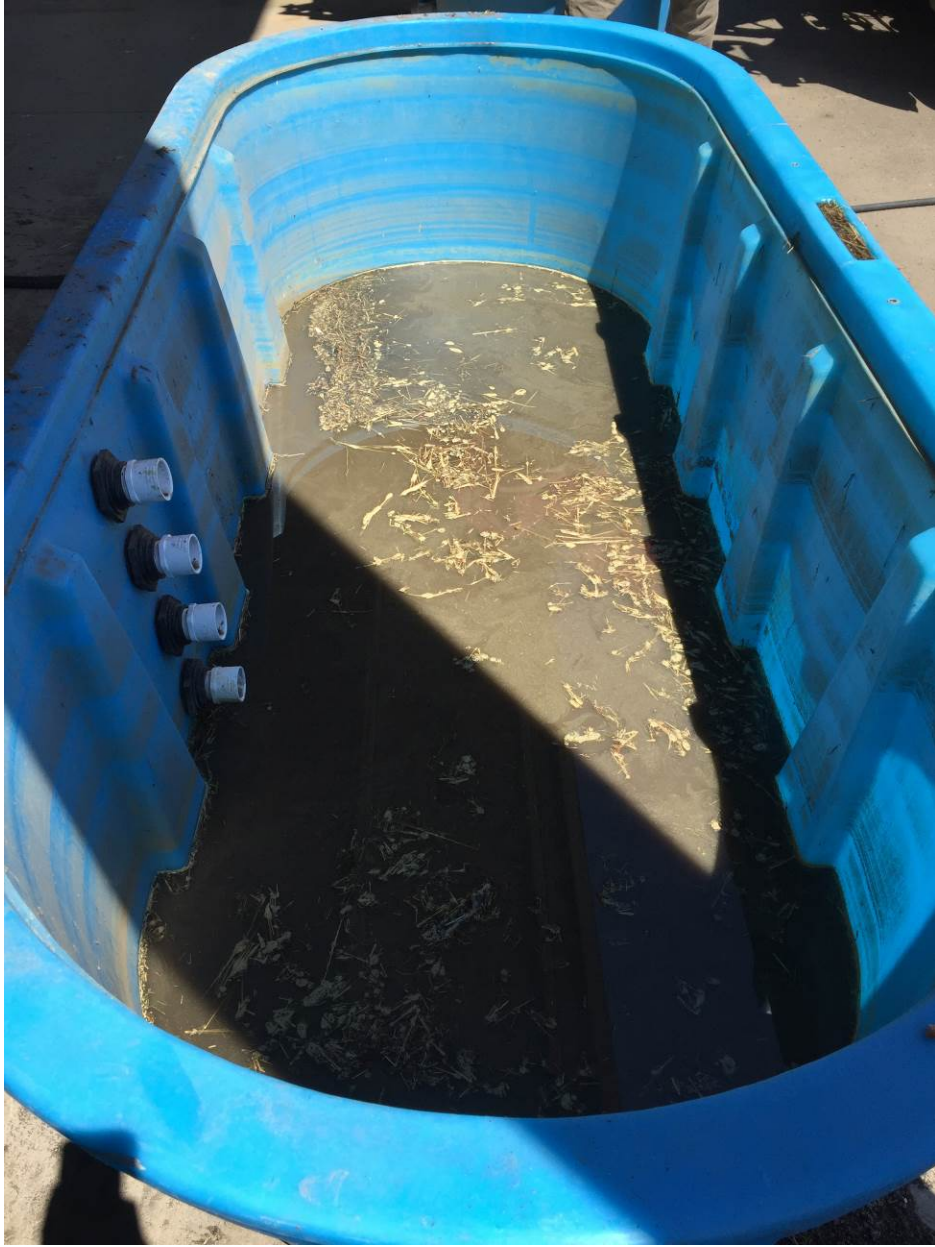
Another picture showing what was collected during the street sweeping. Slight sheen (possibly biological from breakdown of hay?) and hay chaff was observed.

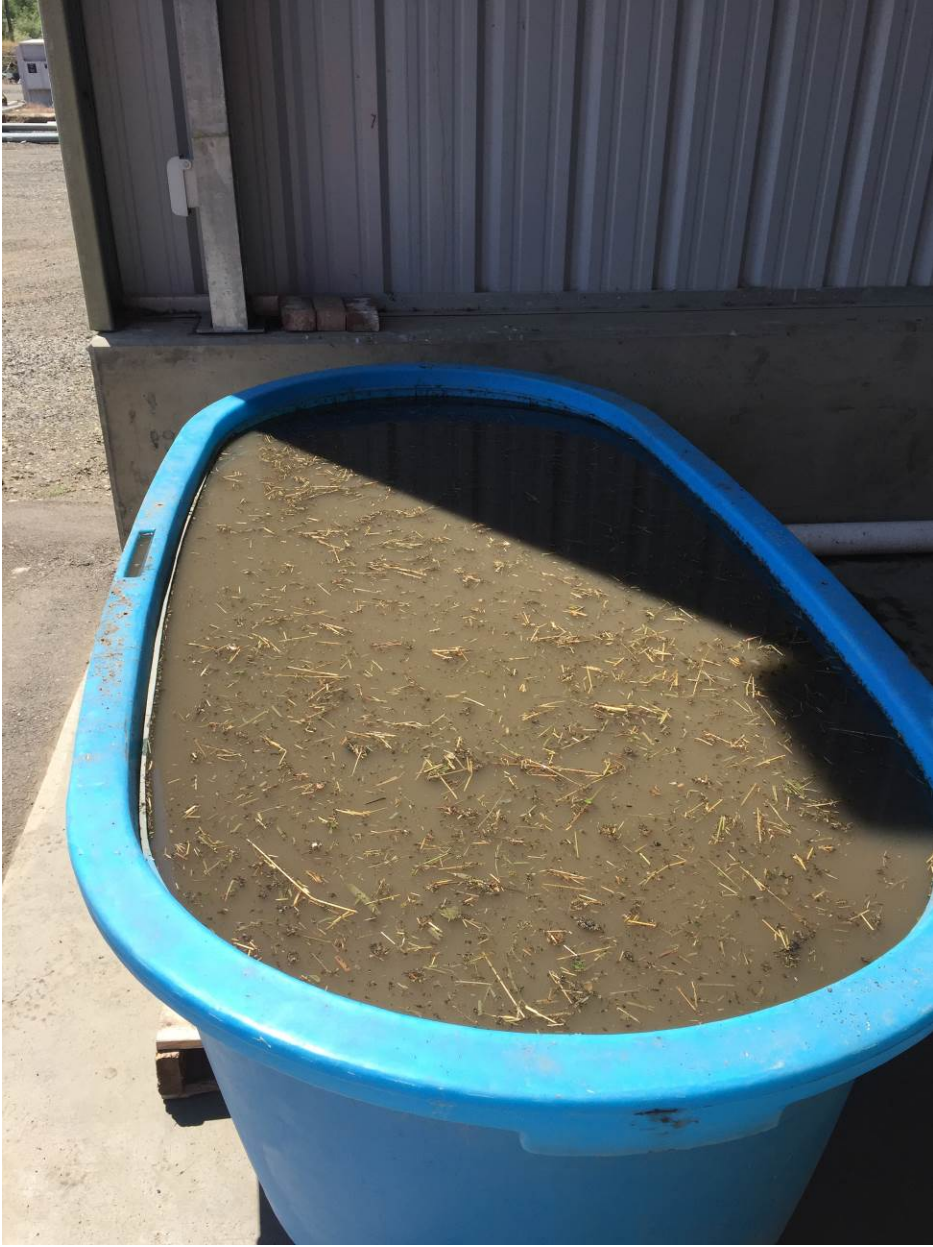
Material collected during catch basin cleaning. Appeared to fill the basin to almost the same depth as in April. Smelled horrible. No dead mice observed.
